**NUMBER:** 23-004-06

Passenger Cabin Water Leakage And/Or Wind-Like Sound

2006 (XK/XH) Commander

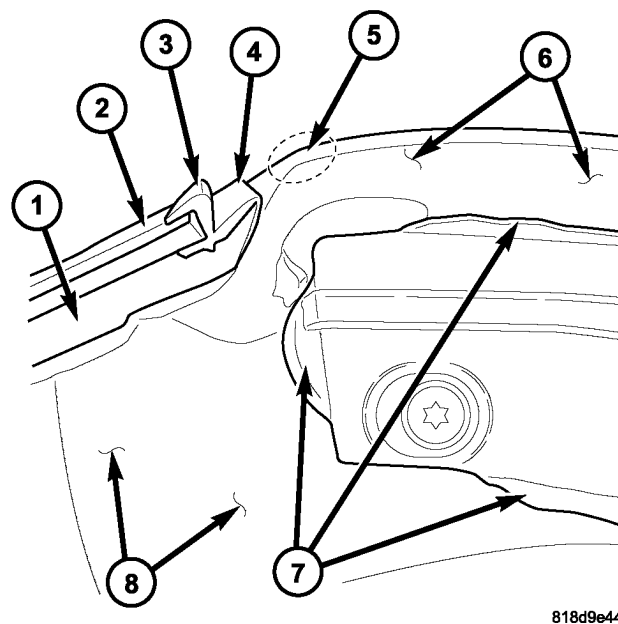
**Fig. 1 WINDSHIELD TOP SEAL LIP**

1. Secondary door seal metal retention bracket has voids in its baked-on adhesive sealant ([Fig. 1](#)). Fix: Refer to Service Bulletin 23-050-05.

1. Top lip of the rubber seal along the top edge of the windshield is too high ([Fig. 1](#)). Fix: Top edge of the rubber seal must be below the radius (bend) of the leading edge of the roof panel. Apply a suitable adhesive to secure seal lip to body.

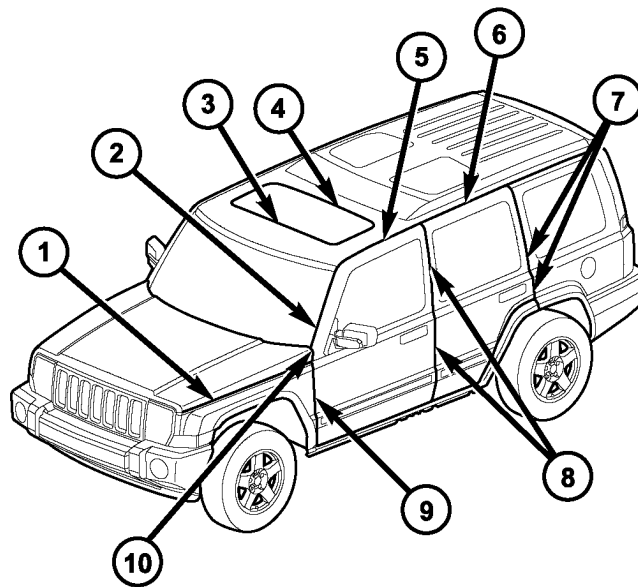
**Fig. 2 XK - GAP & FLUSH**

1. Sunroof over/under flush to the outside surface of the roof panel (Fig. 2). Fix: Adjust sunroof (glass) to obtain the following flush measurement to the roof panel:
  - a. Front edge of sunroof glass: -1.0 mm (+/- 1.0 mm). Glass range: from -2 mm (under flush) to 0 mm (flush) to roof panel.
  - b. Rear edge of sunroof glass: +1.0 mm (+/- 1.0 mm). Glass range: +2 mm (over flush) to 0 mm (flush) to roof panel.
2. Sunroof not centered in roof panel opening. Fix: Adjust sunroof module so that it is centered in opening.
3. Sunroof-to-roof seal has gaps, appears pinched or warped. Fix: Adjust sunroof module to remove imperfections in seal.

1. Front door is over/under flush to surrounding panels (Fig. 2). Fix: Adjust front door to obtain the following flush measurement with adjacent body panel:

2. Front door gap is not to specification (Fig. 2). Fix Adjust front door to obtain following gap measurement with adjacent body panel:
  - a. Front Door to Roof Panel: 6.0 mm (+/- 1.5 mm). Front door range: 4.5 mm to 7.5 mm gap between front door and roof panel.

1. Rear door is over/under flush to surrounding panels (Fig. 2). Fix: Adjust rear door to obtain the following flush measurement with adjacent body panel:

- c. Rear Door to Front Door: 0.0 mm (+/- 1.0 mm). Rear door range: -1.0 mm (under flush) to +1.0 mm (over flush) to front door.
2. Rear door gap is not to specification (Fig. 2). Fix Adjust rear door to obtain following gap measurement with adjacent body panel:

- a. Front Door to Roof Panel: +3.0 mm (+/- 1.5 mm). Front door range: +1.5 mm (over flush) to +4.5 mm (over flush) to roof panel.
  - b. Front Door to Rear Door: 0.0 mm (+/- 1.0 mm). Front door range: -1.0 mm (under flush) to +1.0 mm (over flush) to rear door

- c. Front Door to Fender: +0.5 mm (+/- 1.0 mm). Front door range: -0.5 mm (under flush) to +1.5 mm (over flush) to front fender.
  - d. Front Door to Windshield Molding: +3.0 mm (+/- 1.0 mm). Molding range: +2.0 mm (over flush) to +4.0 mm (over flush) to front door.

- e. Front Door to Fender Alignment: 0.0 mm (+/- 1.5 mm). Front door body line alignment range: - 1.5 mm (below) to +1.5 mm (above) body line of fender.

- b. Front Door to Rear Door: 4.5 mm (+/- 1.0 mm). Front door range: 3.5 mm to 5.5 mm gap between front door and rear door.
  - c. Front Door to Fender: 4.5 mm (+/- 1.25 mm). Front door range: 3.25 mm to 5.75 mm gap between front door and fender.

- d. Front Door to Hood: 6.0 mm (+5.0mm / -1.0 mm). Front door range: 5.0 mm to 11.0 mm gap between front door and hood.
  - e. Front Door to Windshield Molding: 6.0 mm (+/- 2.0 mm). Front door range: 4.0 mm to 8.0 mm gap between front door and plastic windshield molding.

- a. Rear Door to Roof Panel: +3.0 mm (+/- 1.5 mm). Rear door range: +1.5 mm (over flush) to +4.5 mm (over flush) to roof panel.
  - b. Rear Door to Rear Quarter Panel: 0.0 mm (+/- 1.0 mm). Rear door range: -1.0 mm (under flush) to +1.0 mm (over flush) to rear quarter panel.

- a. Rear Door to Roof Panel: 6.0 mm (+/- 1.5 mm). Rear door range: 4.5 mm to 7.5 mm gap between rear door and roof panel.
  - b. Rear Door to Rear Quarter Panel: 4.5 mm (+/- 1.0 mm). Rear door range: 3.5 mm to 5.5 mm gap between rear door and rear quarter panel.

- c. Rear Door to Front Door: 4.5 mm (+/- 1.0 mm). Rear door range: 3.5 mm to 5.5 mm gap between rear door and front door.

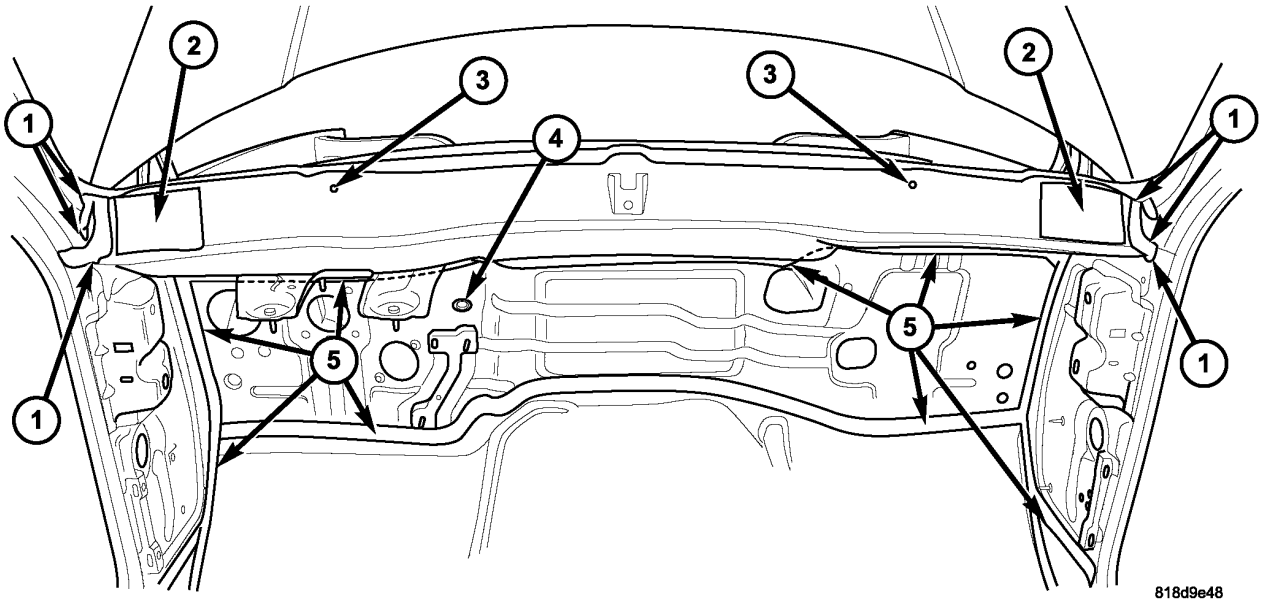
**Fig. 3 COWL - INTERIOR VIEW**

1. Two cowl panel studs, that are used to support the IP and the inside IP insulation blanket, are not sealed to the inside cowl panel. The head of each stud is sealed by a round mastic patch from outside of the vehicle, in the cowl plenum chamber. Studs can not easily be inspected from inside vehicle. Remove the cowl screen. With a mirror or hand, inspect both stud heads for the round mastic patch and proper centering of the patch over the stud head. Inspection may be difficult (Fig. 3). Fix: From the cowl plenum chamber, apply a suitable adhesive sealant to stud heads.

1. Gap or voids in bulkhead panel seam sealer. Bulkhead panel joints with other body panels (cowl, A-Pillar side panel, floor, etc) may not be completely sealed. Remove inside kick panel trim. Pull back front of carpeting and sound insulation blanket to inspect bulkhead seams (Fig. 3). Fix: Apply a suitable flowable or pumpable adhesive sealant into the various bulkhead joint seams.

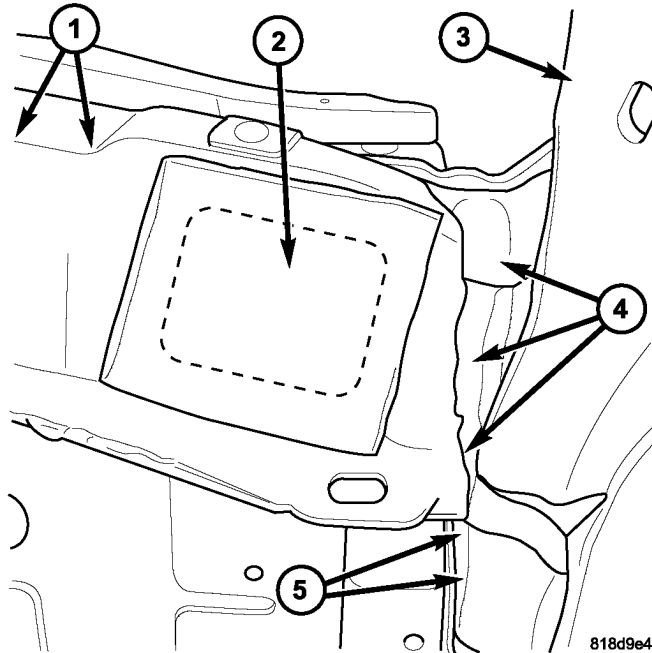
**Fig. 4 COWL OPENING MELT DOWN PATCH**

1. Melt down patch not covering opening in inside cowl panel. A melt down patch is located behind instrument panel (IP) at each far end of the inside cowl panel. Remove IP plastic side panels (end caps) from IP. Use your hand to reach up and feel for the melt down patch and its proper centering to over the cowl opening (Fig. 3) (Fig. 4). Fix: First attempt to press patch to the cowl body panel. Verify if patch adhesive is sufficient to remain retained to the cowl body. Apply a suitable flowable or pumpable adhesive sealant or mastic tape into the cover opening, as required.

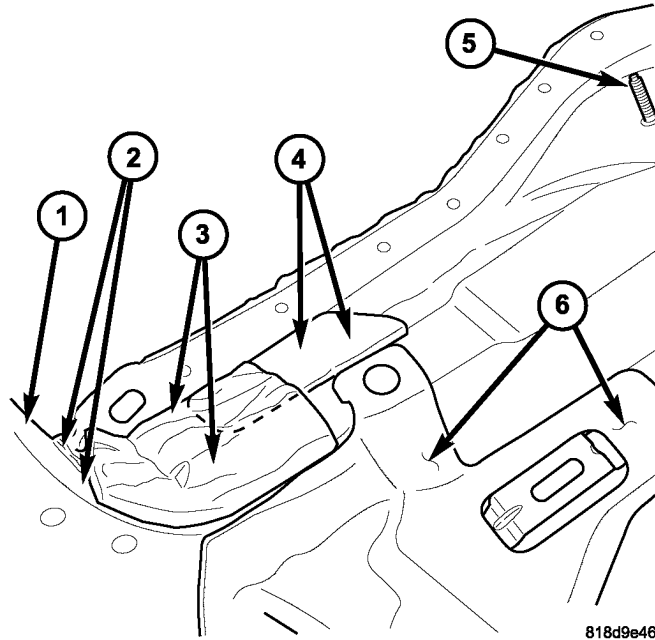
**Fig. 5 A-PILLAR TO COWL MASTIC PATCH**

2. Large inside joint, at lower corner of windshield, not sealed. A mastic (foil backed) patch is applied to joint. Patch may not be positioned correctly or properly pressed in place. Several panels come together to create the joint. Remove upper A-Pillar interior trim at windshield. Remove IP plastic side covers (end caps). Use a bright shop light to help with repair. Joint must be inspected from two locations. The top portion of the joint can be inspected while viewing through the windshield and with the shop light placed inside IP through side cover opening. The lower portion of the joint can be inspected through the side of the IP when the side cover is removed and the shop light is placed above at the top portion of the joint (Fig. 3) (Fig. 4) (Fig. 5). Fix: Apply a suitable flowable or pumpable adhesive sealant into joint. Seal entire joint well.

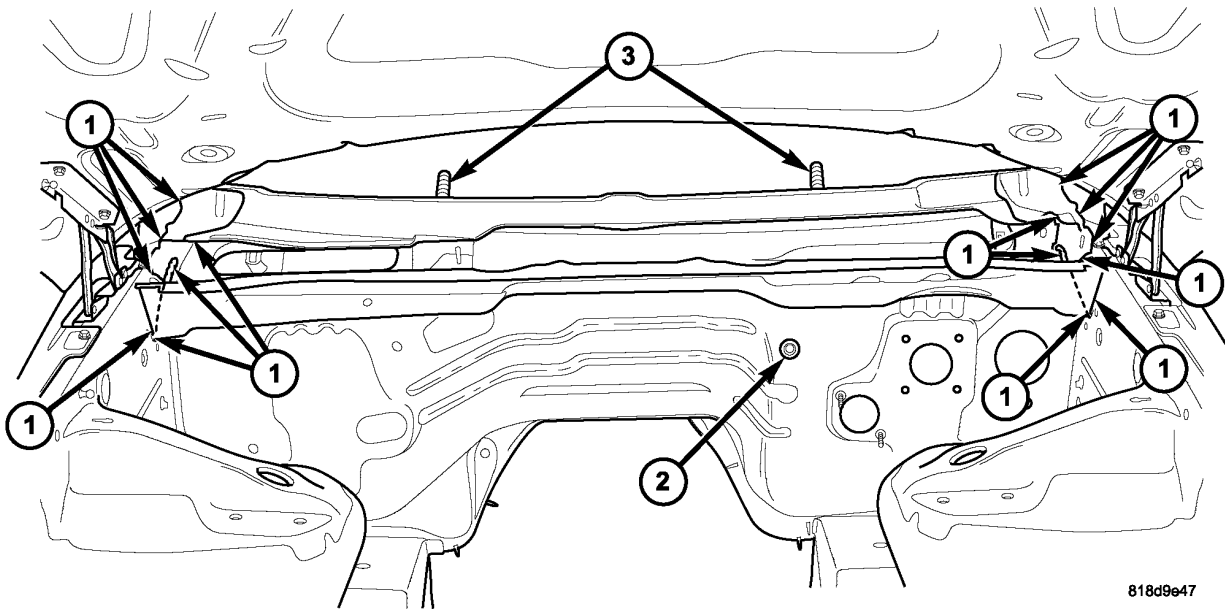
**Fig. 6 COWL - EXTERIOR VIEW**

1. Accelerator cable delete plug missing from or loose to bulkhead panel ([Fig. 6](#)). Fix: Install plug.

1. Gap or voids in cowl joint seam sealer. Remove the cowl screen and HVAC baffle screen. HVAC baffle screen may not need to be fully removed to effect a good seal repair. With a mirror or hand, inspect inside the cowl plenum chamber. Inspect all cowl panel seams, especially the various seams at either end of the cowl plenum chamber (top joints and lower joints) (Fig. 6). Fix: Joints can be sealed from outside and inside the vehicle. Apply a suitable flowable or pumpable adhesive sealant into the various cowl joint seams. Sealant may be applied to the outside joints visible from the cowl chamber, from outside under the cowl chamber, and from inside under the cowl chamber. The inside joint may require the removal of the side trim panel and pulling the carpet and sound insulation blanket out of the way.
