NUMBER: 23-022-06

Whistle-Like Sound Due To Cabin Air Passing Through The Sunroof Front Drain Tube

2006 (XK/XH) Commander

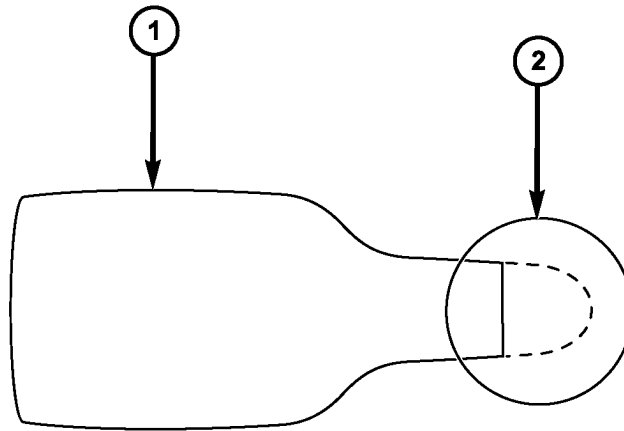
Fig. 1 END CAP WITH 8 MM REMOVED

- 1 - Plastic End Cap
- 2 - Remove 8 mm (5/16 inch) Of Material From The Tip Of The End Cap

-
1. Trim **8 mm (5/16 in.)** of material from the tip of the new cap. This will create a drain hole in the cap ([Fig. 1](#)).
 2. Remove the front door sill scuff plate.
 3. Remove the lower A-Pillar cowl (kick) panel. Refer to the detailed service information available in TechCONNECT, under: Service Info > 23 - Body > Interior > Cowl Trim > Removal and Installation.
 4. Remove the molded end grommet of the sunroof front drain tube from the vehicle body.
 5. Slide the new modified cap over the molded end grommet of the drain tube ([Fig. 2](#)).

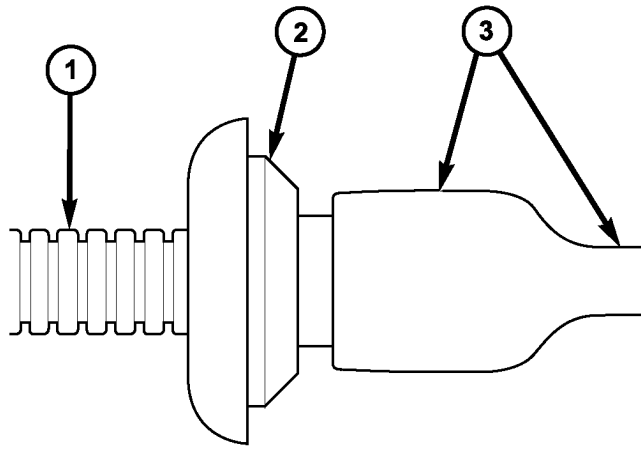
Fig. 2 DRAIN TUBE GROMMET WITH CAP

- 1 - Sunroof Front Drain Tube Hose
- 2 - Front Drain Tube Hose Molded End Grommet
- 3 - New End Cap Installed Over Molded End Grommet

6. Install the molded end grommet of the drain tube to the vehicle body.

NOTE: Verify that the drain tube end grommet is FULLY seated to the body.
